**FEDERAL AVIATION ADMINISTRATION
AIRWORTHINESS DIRECTIVES
SMALL AIRCRAFT, ROTORCRAFT, GLIDERS,
BALLOONS, & AIRSHIPS**

BIWEEKLY 2001-08

**MD HELICOPTERS
AIRWORTHINESS DIRECTIVE
SMALL AIRCRAFT, ROTORCRAFT, GLIDERS, BALLOONS, & AIRSHIPS**

2001-07-09 MD HELICOPTERS INC: Amendment 39-12175. Docket No. 2000-SW-15-AD. Supersedes Emergency AD 99-26-20, Docket No. 99-SW-89-AD.

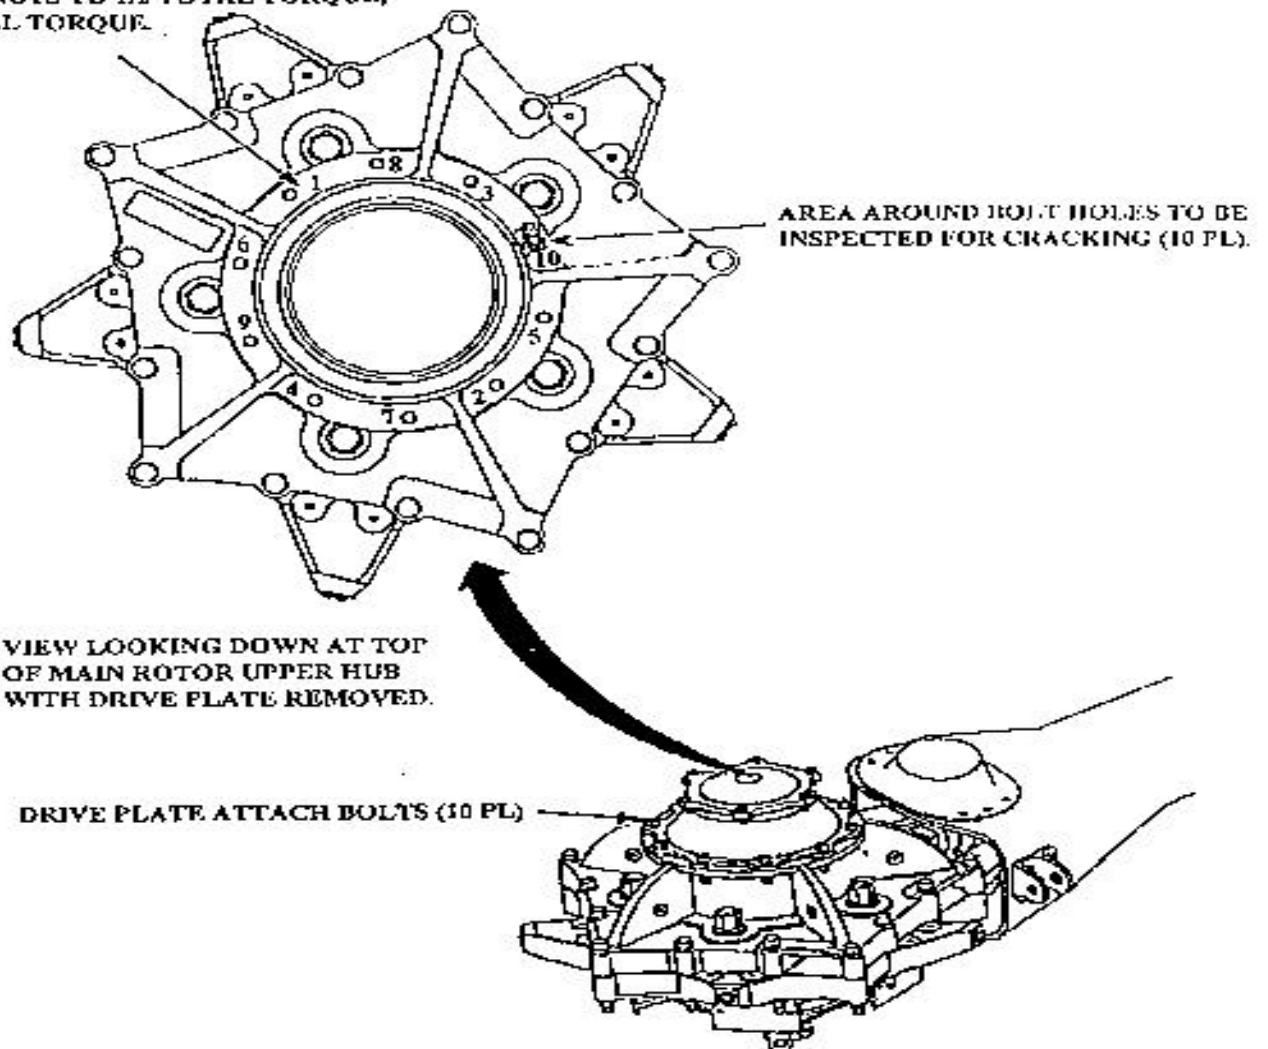
Figure 1. Main Rotor Upper Hub Assembly Inspection.

1. MAIN ROTOR DRIVE PLATE ATTACHMENT
HARDWARE TORQUE SEQUENCE.
2. NUMBERING MAY START AT ANY HOLE.
3. TORQUE NUTS TO 1/2 TOTAL TORQUE,
THEN FULL TORQUE.

(ii) Mark the main rotor hub holes, bolts, and nuts to correspond with the drive plate hole numbers (see Figure 1).

(viii) Reinstall the main rotor drive plate using 10 new sets of replacement attachment hardware. Torque the nuts to 160 inch pounds above locknut locking/run-on torque in the sequence shown (Figure 1). Record in the rotorcraft logbook, or equivalent record, the locknut locking/run-on torque for each nut.
